# METALLURGICAL TECHNOLOGIES, Inc.

**Report Number 2020357-1**  
**October 30, 2020**

**Re: Load Testing of M20 Blind Bolt Assemblies**

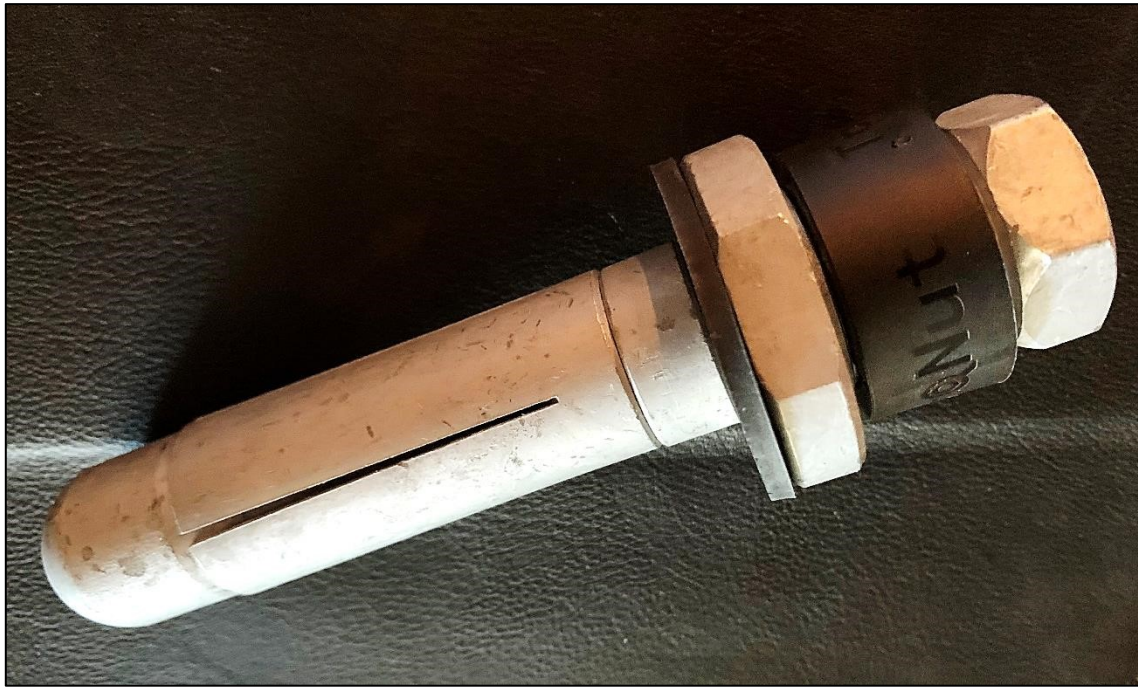
Figure 1: Photograph of the client supplied M20 blind bolt assembly with a M20 Torqnut prior to installation and testing. (client supplied photo)

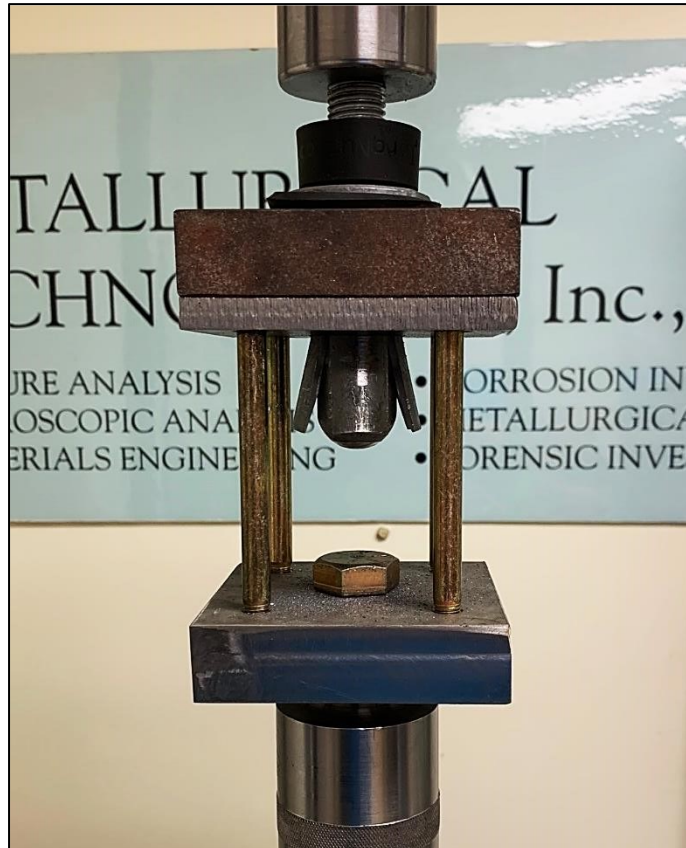
Table 1 Tensile Testing		
Plate thickness	Ultimate Load (lbft)	Mode of Failure
1/8"	3,480	Bolt pull Through
3/16"	16,200	Bolt pull Through
1/4"	23,410	Bolt pull Through
3/8"	28,900	Bolt pull Through
1/2"	38,100	Bolt pull Through

Figure 2: Photograph of the M20 blind bolt installed into the tensile test fixture prior to testing. Table 1 provided the maximum

load to pull the bolt through the narrower plate of different thicknesses. (Photo 20357-N01)

The assembly in Figure 2 was loaded in tension until the bolt pulled through the hole in the thinner plate. The maximum load was recorded. Results are tabulated with Figure 2.
