BLIND BOLT TENSION AND SHEAR TESTING

TORQNUT™

Date:	June 9, 2020
Author:	Mike Aylward
Report Number:	ESP033388P.1R0
Purchase Order Number:	00T000120

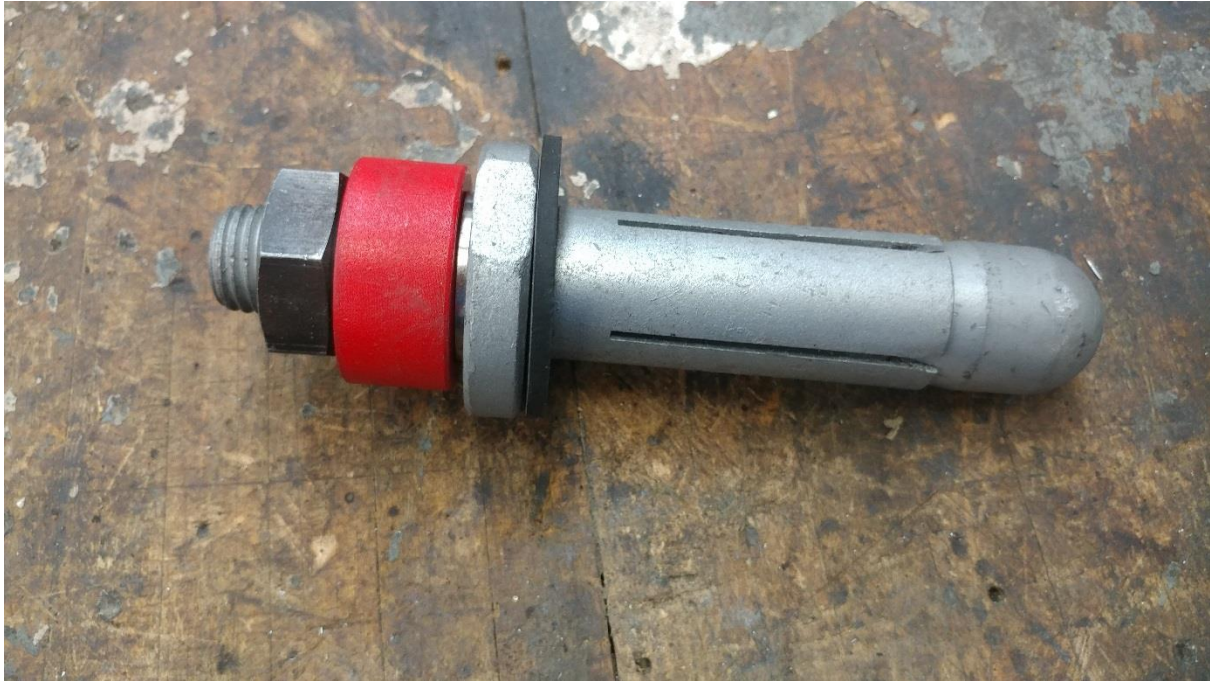
Figure 1: Tension Test Specimen before testing

A fixture was created to allow a blind bolt to be installed into two 1 inch thick plates through two 1.1875 inch diameter holes. The blind bolt was tightened to a given torque value as instructed by TorqNut. The fixture allowed the two 1 inch plates to be pulled apart until the bolt either failed or slipped through the plates. The plates were installed into a tension/compression load frame and pulled in opposite directions normal to the plates' largest surface creating a tensile load along the bolts longest axis. Loading was conducted at a rate of 0.25 inches per minute. Load data was recorded and the maximum load achieved was reported.

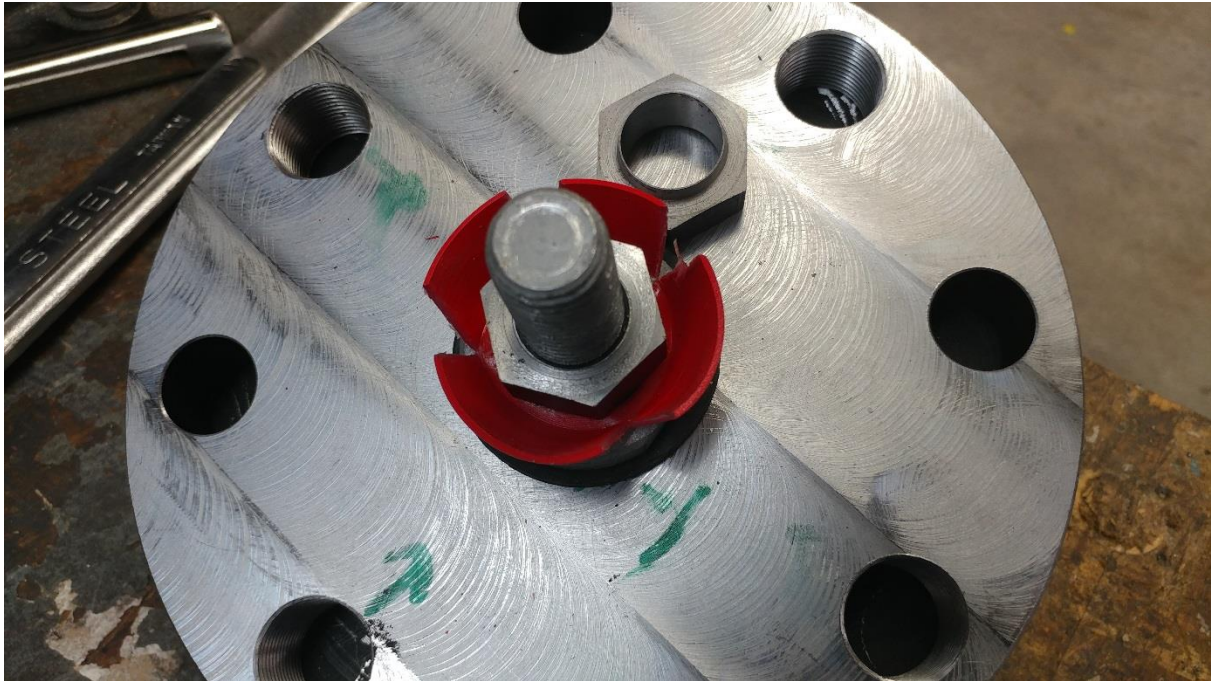
Figure 2: Tension Test Specimen after installation (nut shown sheared at 120 ft lbs)

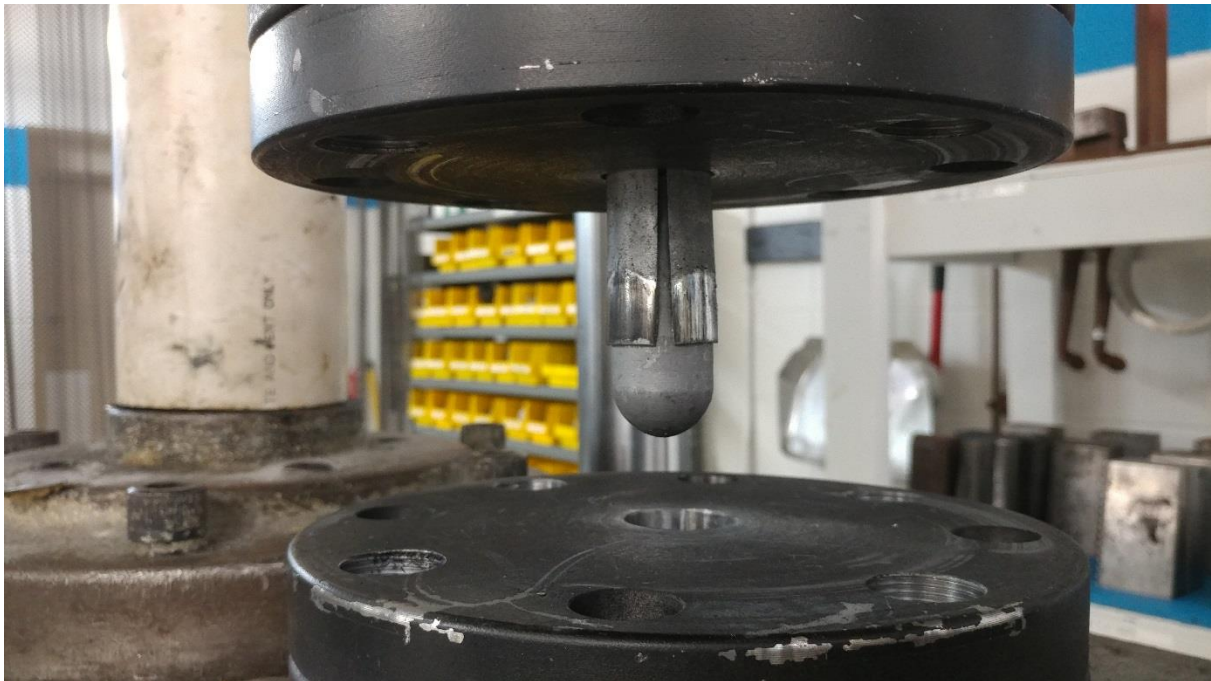
Figure 3: Tension Test 1 (120 ft lb installation) after testing

Tension Test 1: installation torque: 120 ft lbs, maximum load: 39172 lbf, failure mode: pull through, minimum factored tension: 33296 lbf

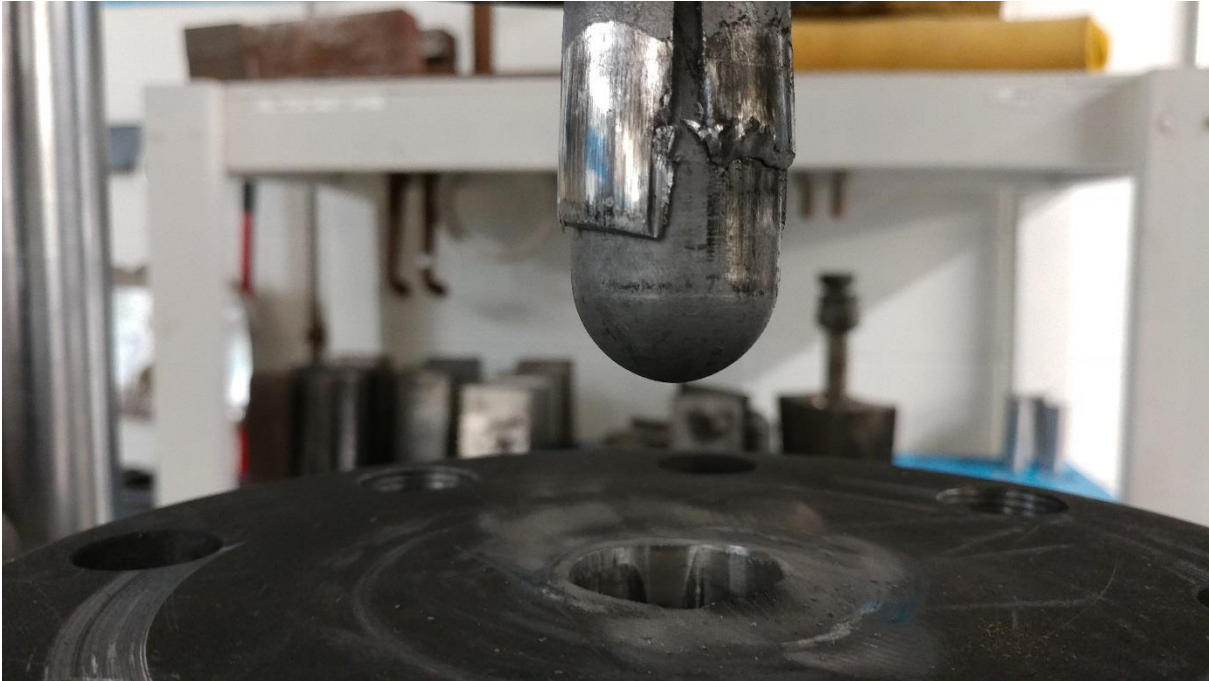
Figure 4: Tension Test 2 (180 ft lb installation) after testing

Tension Test 2: installation torque: 180 ft lbs, maximum load: 54342 lbf, failure mode: pull through and shear of wing tabs, minimum factored tension: 46191 lbf

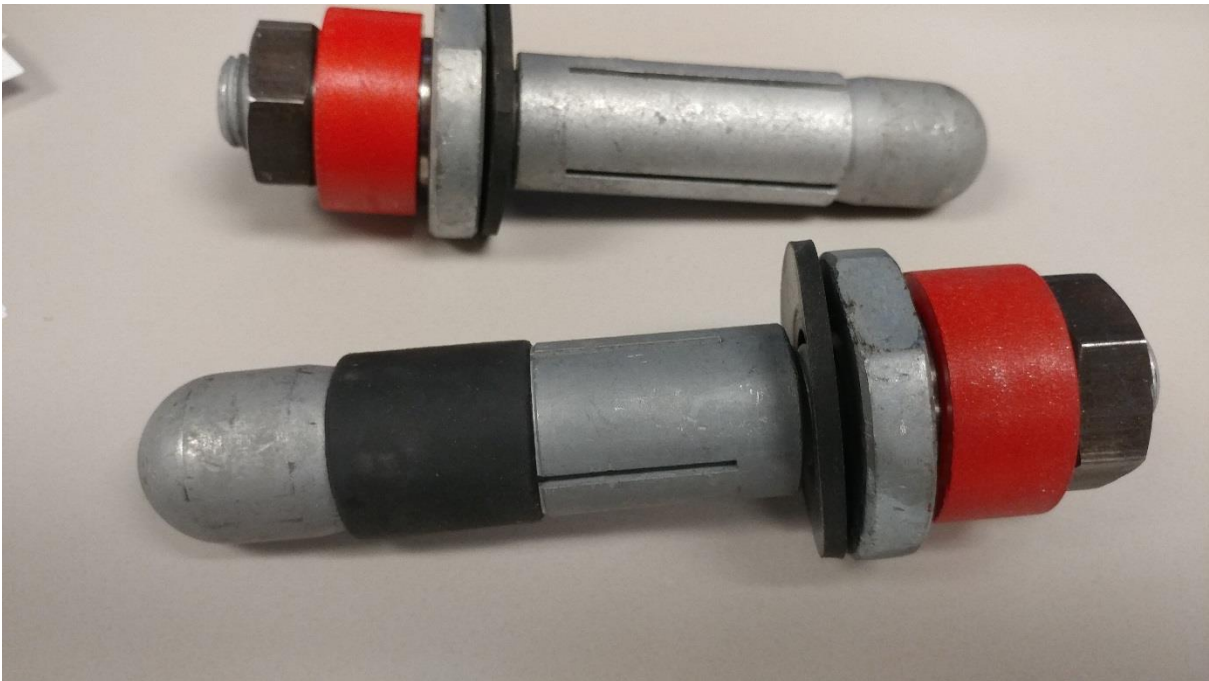
Figure 5: Shear Test Specimens before testing

A fixture was created to apply a shear load to two blind bolts simultaneously in order to balance bending forces on the uniaxial load frame used for testing. Each anchor was installed into two 1 inch plates through 1.1875 diameter holes. The blind bolts were tightened to 180 foot pounds as instructed by TorqNut. Each set of plates was installed into tension/compression load frame so that the shear forces were evenly distributed between the two blind bolts. The plates were pulled in opposite directions along the plates' largest surface creating a shear load on each blind bolt. Testing was stopped when one of the two blind bolts failed.

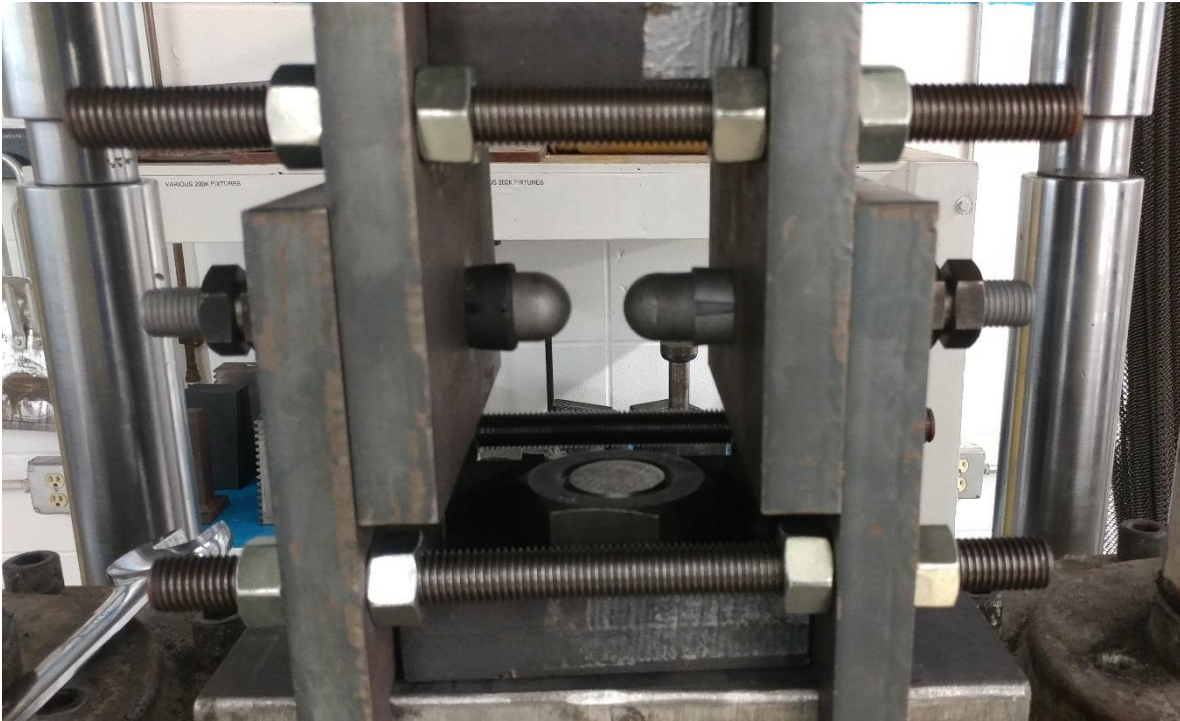
Figure 6: Shear Test Specimens installed before testing

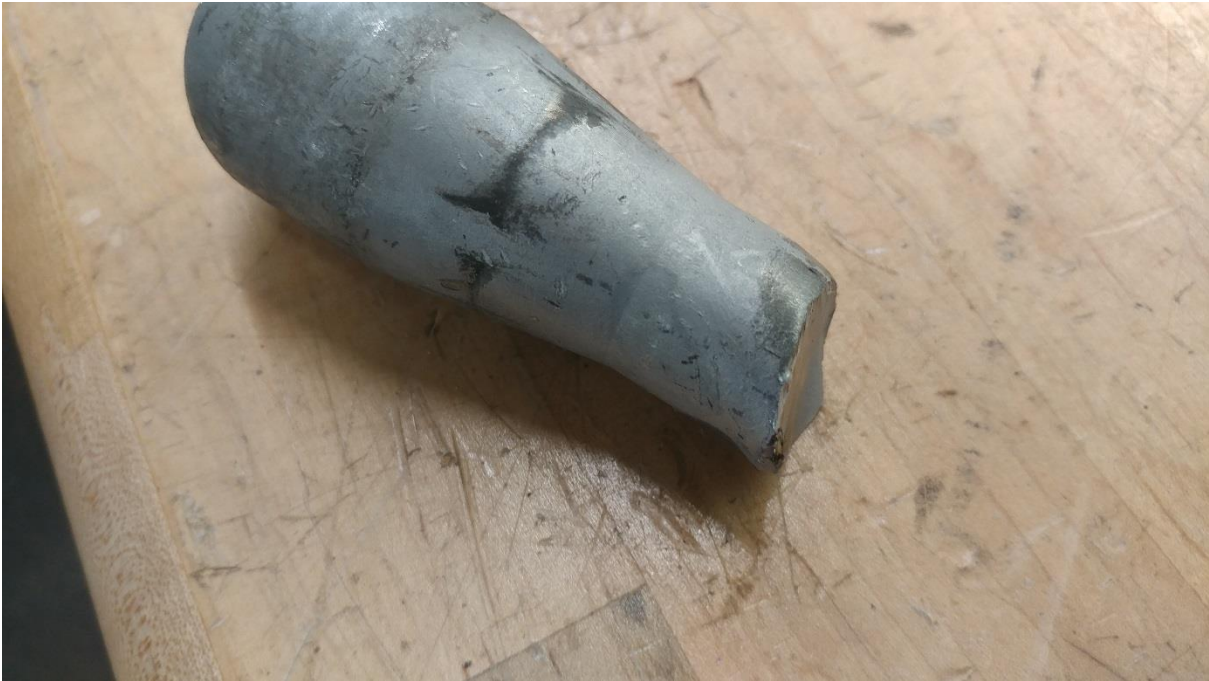
Figure 8: Shear Test Specimen after testing

Shear Test: installation torques: 180 ft lbs, maximum load: 122896 lbf, failure mode: shear fracture of one bolt, minimum factored shear: 46086 lbf
